**Project :** Bank Of America #5133  
5651 E. Lancaster Ave.  
Ft. Worth, Texas 76112

A roof inspection and infrared thermal scan was performed at the above referenced property on April 8, 2010 during the evening hours and a follow up inspection was made on Monday April 12, 2010 to verify and to identify any problem areas on the existing roof.

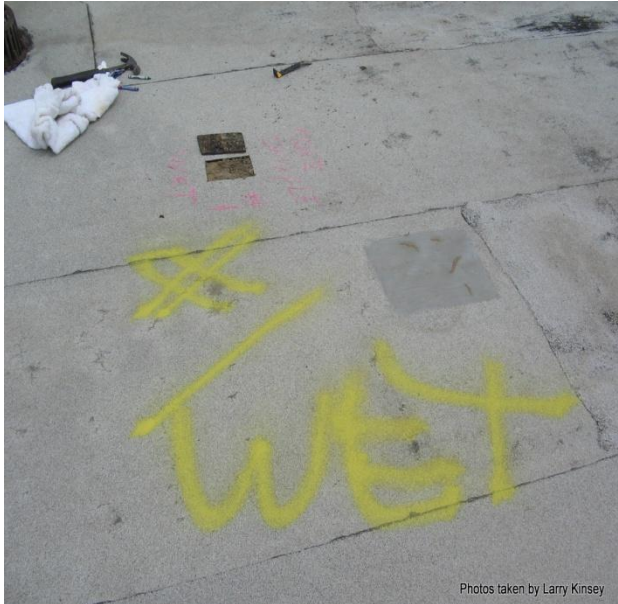
Photo # 1	Description [ wet #1 ]

<p style="font-size: small; text-align: right;">Photos taken by Larry Kinsey</p>	<p>Core sample photo taken on west low roof. This area was verified as total saturation of moisture. The sample was taken approx. 15 ft. from the south eave of roof.</p> <p>The core sample was retained for any future reference. The roof consists of one ply of fiberglass base sheet and one ply of modified APP membrane that was heat welded. This is considered as a 10-12 year type roof</p> <p>Core samples were repaired with plastic cement and fiberglass membrane</p>

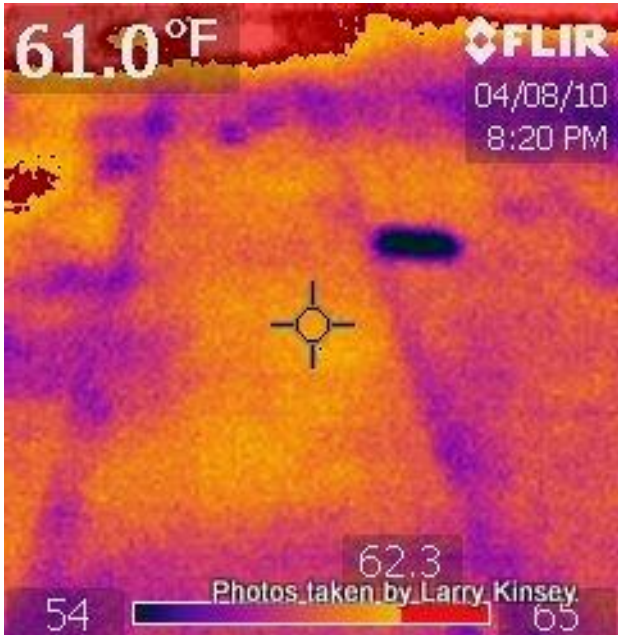
I-R Photo # 2	Description

<p style="font-size: small; text-align: center;">Photos taken by Larry Kinsey</p>	<p>This is the corresponding photo to the above photo taken from a distance to encompass the area. The lighter colors in the I-R photo show the heaviest concentration of moisture below the roof membrane.</p> <p>This same area has openings in the modified membrane and will require some immediate repairs. There is evidence of previous impact marks from possibly old hail damage.</p>

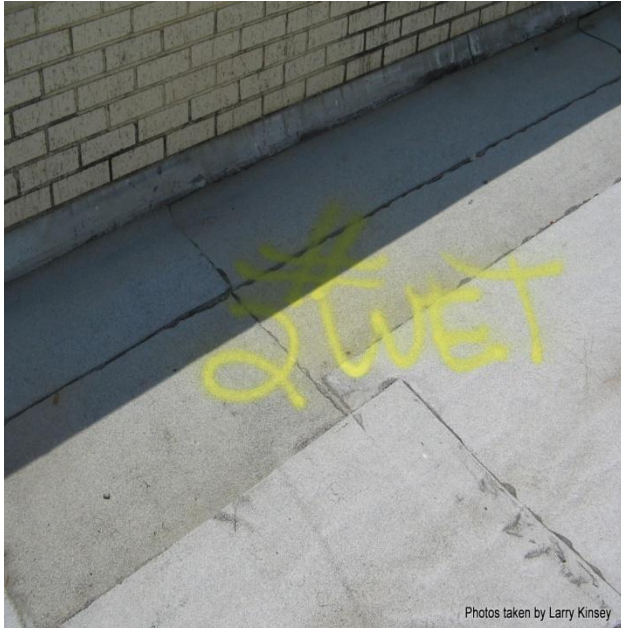
Photo # 3	Description [ wet # 2 ]

<p>Photos taken by Larry Kinsey</p>	<p>This area was determined wet using the infrared camera and followed up with a non destructive moisture meter.</p> <p>This area is on the west low roof adjacent to the raised penthouse on northwest corner.</p> <p>The penthouse roof was checked with a moisture meter and was dry. There is evidence that 2 layers of roofing were applied over the penthouse roof.</p>

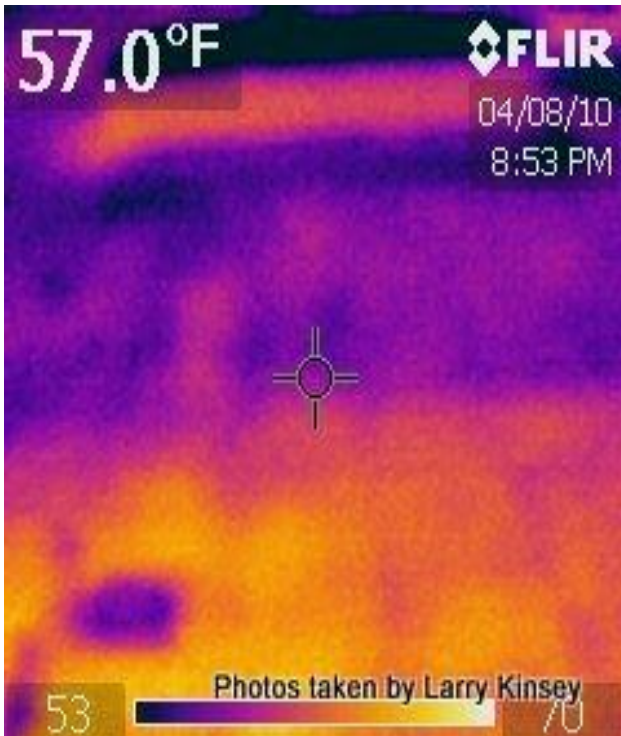
I-R Photo # 4	Description

<p>Photos taken by Larry Kinsey</p>	<p>The corresponding I-R photo verifies moisture along the penthouse base.</p> <p>All areas were marked with stripping paint to verify field conditions and areas where moisture was located.</p>

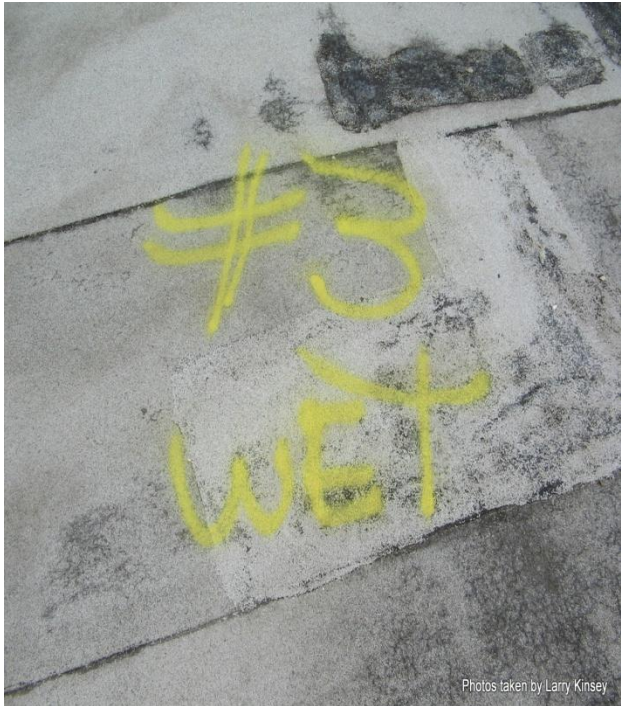
Photo # 5	Description [ wet # 3 ]

<p>Wet # 3 was taken in same general area on the west roof approx. 80 ln. ft. from west eave and 60 ft. from south eave.</p> <p>A moisture meter was used to verify digital photo. There are some open areas through the membrane that allow moisture to penetrate the membrane.</p> <p>It is recommended that the underside of decking be inspected in the interior attic for any rusting due to extended periods of moisture in the light weight insulating concrete fill.</p>

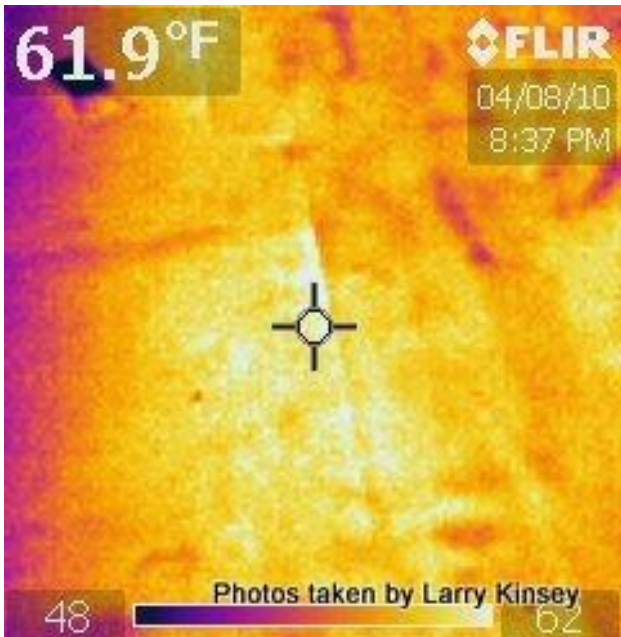
I-R Photo # 6	Description

<p>This corresponding photo to the above shows total saturation below the membrane and was verified with a Tramex Moisture meter during the follow up inspection.</p>

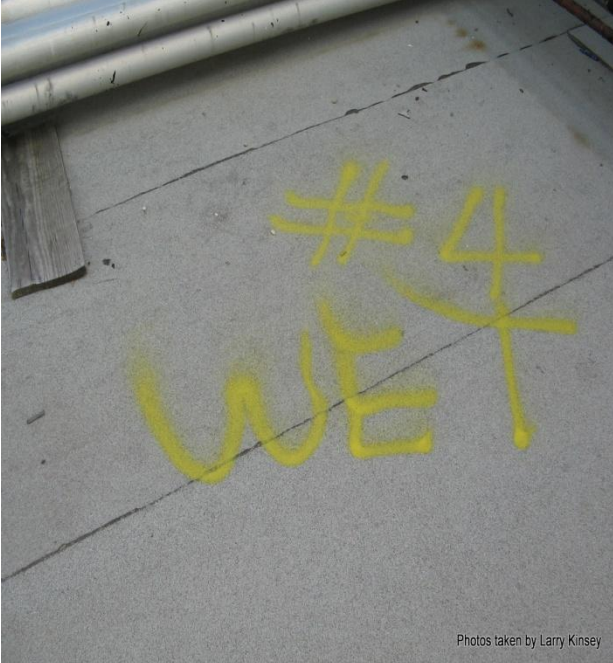
Photo # 7	Description [ Wet # 4 ]

<p>Photos taken by Larry Kinsey</p>	<p>This area is noted on roof and is near the expansion joint on north side of low roof next to the overhang. The moisture content was saturated in this area.</p>

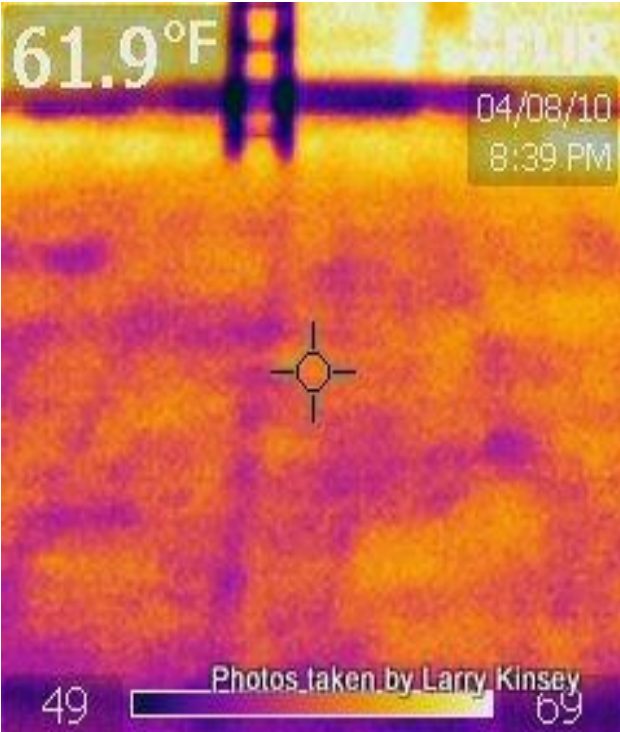
IR Photo # 8	Description

<p>Photos taken by Larry Kinsey</p>	<p>This IR photo is a general overview of the moisture laden area corresponding to the same as photo above.</p> <p>Most of the roof area on west roof had some form of moisture penetration. The light weight concrete fill has been acting as a sponge and slowly accumulating moisture below the modified membrane.</p> <p>The lighter color shows the heaviest concentrations.</p> <p>There didn't seem to be any concentrations north of the expansion joint that divides the roof off set.</p>

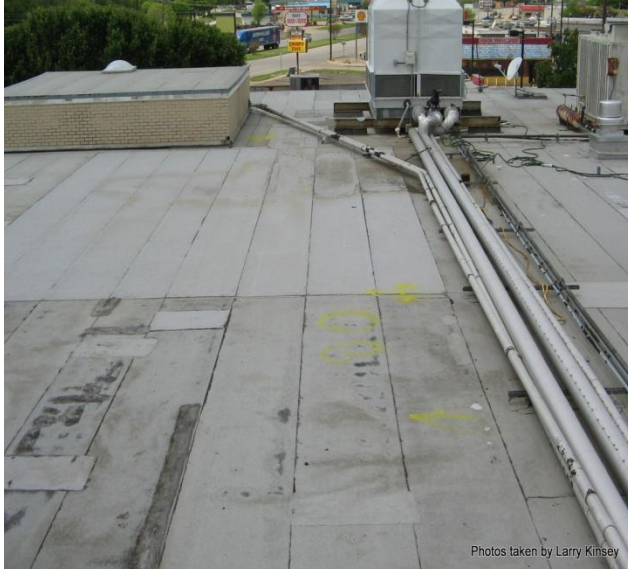
Photo # 9	Description

<p>Photos taken by Larry Kinsey</p>	<p>This view is looking west towards the end of the low roof. With exception to the small pent house roof , most of this area had moisture below the membrane.</p> <p>The IR photo below shows a very good view of the thermal image.</p>

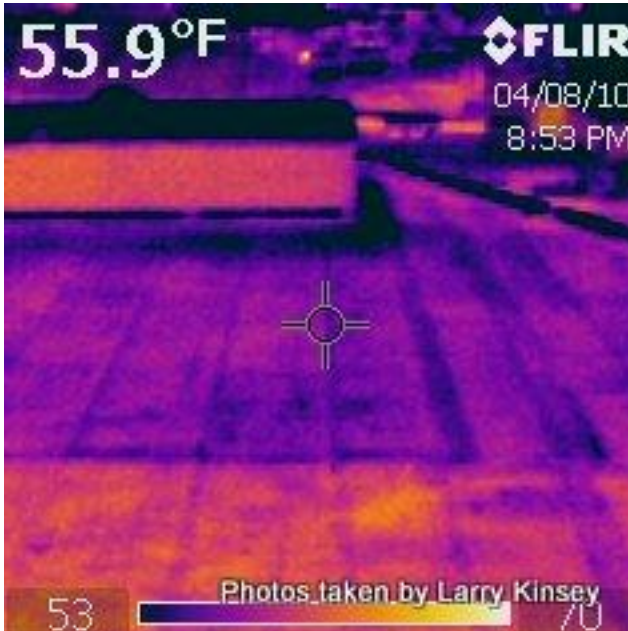
IR Photo # 10	Description

<p>55.9°F</p> <p>FLIR</p> <p>04/08/10</p> <p>8:53 PM</p> <p>53 70</p> <p>Photos taken by Larry Kinsey</p>	<p>This corresponding IR shows an over view of the thermal image relating to the above location</p> <p>It also shows moisture below the previous patch work.</p> <p>All areas were verified with a Tramex moisture meter.</p>

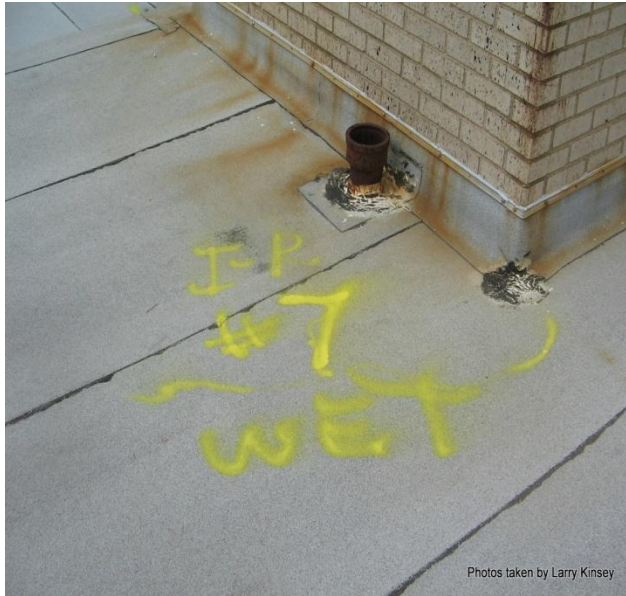
Photo # 11	Description [ 2 story level ]
------------	-------------------------------

This area is located towards the front of the 2 story portion at the northeast corner of the fireplace.

A core sample was done nearby and was the same roof type and system as described in the report.

Was verified with meter.

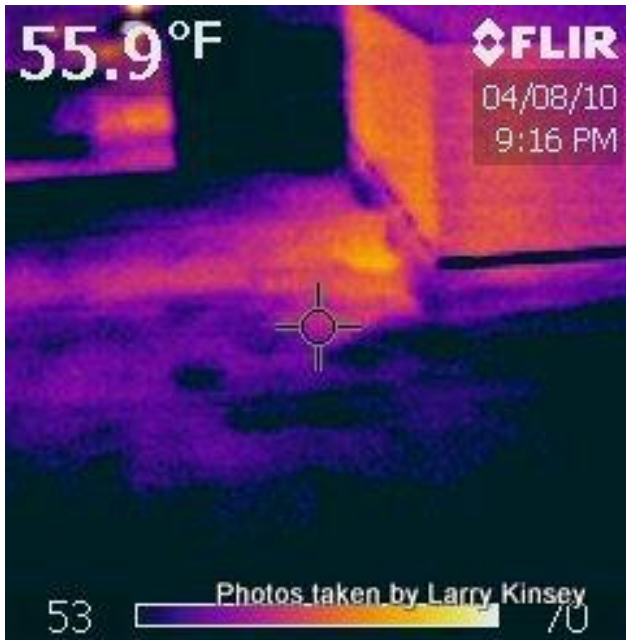
I R Photo # 12	Description @ Chimney
----------------	-----------------------

The corresponding IR photo shows a heavy concentration of moisture in the corner then a gradual decrease with the lighter shades migrating to black, which indicates a dry surface.

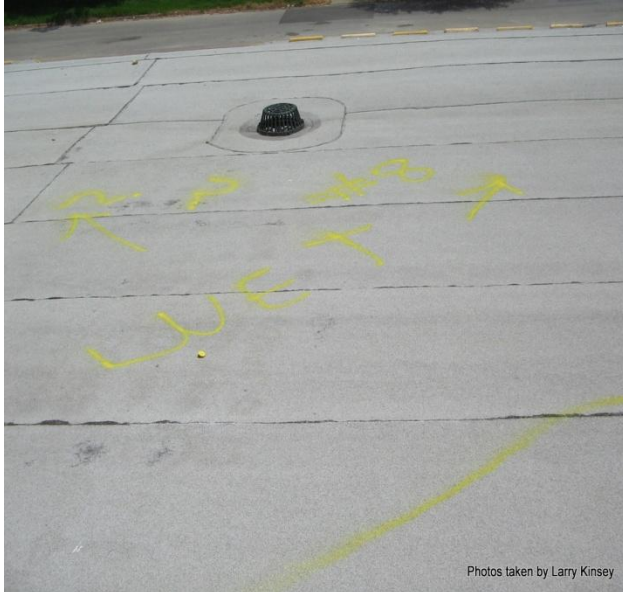
Photo # 13	Description [ 2 story level ]

<p>Photos taken by Larry Kinsey</p>	<p>This location is marked as # 8 on the upper roof near a roof drain.</p> <p>The moisture meter shows that the light weight concrete was damp.</p>

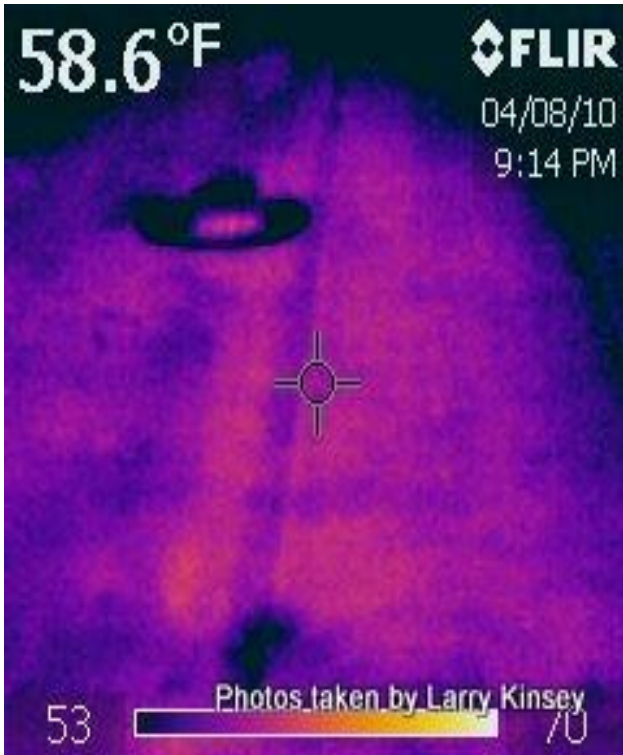
IR photo # 14	Description [ 2 story ]

<p>Photos taken by Larry Kinsey</p>	<p>The IR photo confirms moisture below the membrane but not as concentrated.</p> <p>A core sample was taken nearby within 8-10 ft and the deck surface was damp but not saturated.</p> <p>Core sample was retained for reference and repaired with plastic cement and fiberglass membrane.</p>

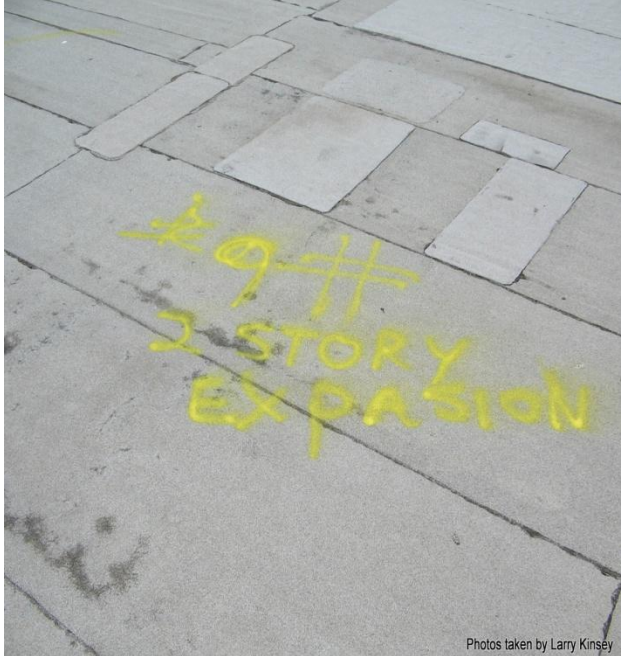
Photo # 15	Description [ 2 story ]

<p>Photos taken by Larry Kinsey</p>	<p>This location is towards the north end of the 2 story portion adjacent to the roof expansion joint.</p> <p>The area is marked as # 9 for future reference on the roof.</p>

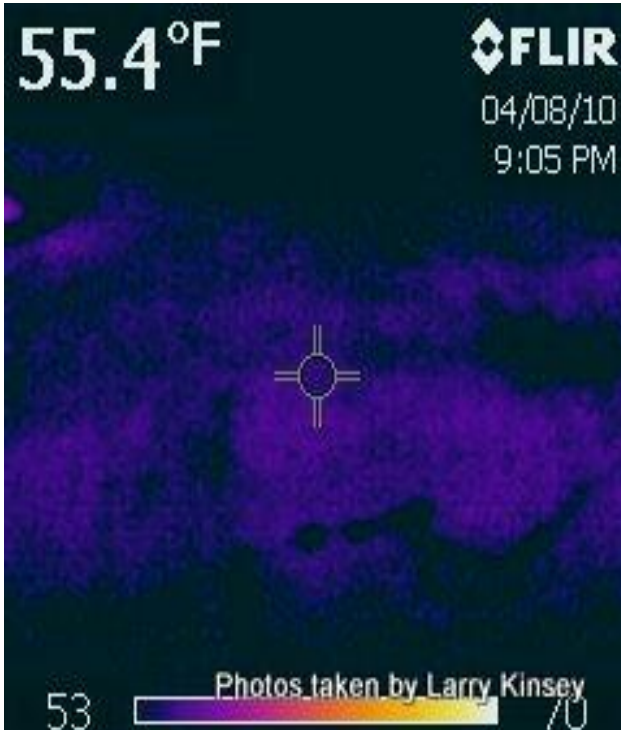
IR Photo # 16	Description

<p>55.4°F</p> <p>FLIR</p> <p>04/08/10 9:05 PM</p> <p>53 70</p> <p>Photos taken by Larry Kinsey</p>	<p>The Infrared here shows dampness and was not totally saturated unlike the lower roof.</p> <p>It was noted that the end laps running across this roof were not installed according to manufacture specifications.</p> <p>As shown in the photo the color changes with the extent of moisture.</p>

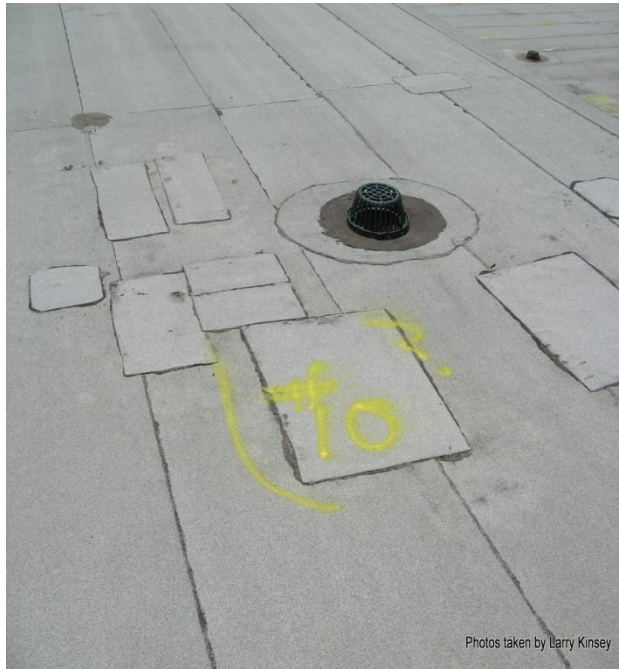
Photo # 17	Description [ 2 story ]
------------	-------------------------

This digital photo shows and area # 10 marked on roof near a roof drain on the west side of upper roof.

Moisture concentration and verification was made with a moisture meter.

Evidence of previous patch work indicates previous leaks.

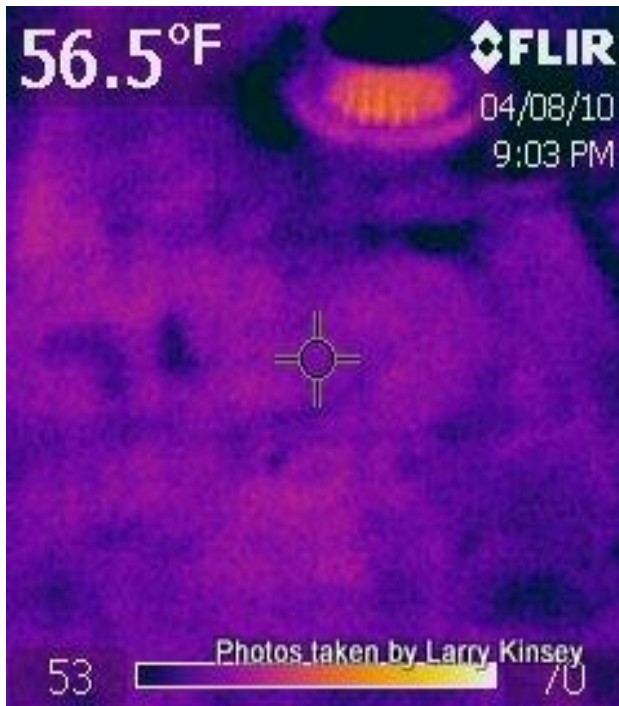
IR photo # 18	Description 2 story
---------------	---------------------

IR photo # 18 shows dampness around and near the roof drain.

Upon inspection it was noted that not all drains had lead flashings and this will contribute to roof leaks around drains.

The manufactures require leads around all drains with modified membranes.

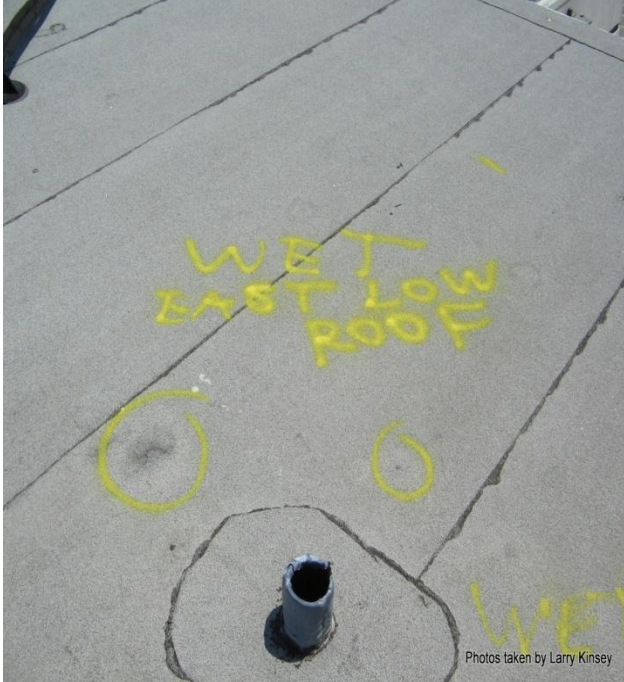
Photo # 19	Description east low roof

<p>Photos taken by Larry Kinsey</p>	<p>Photo # 19 shows a wet section on the east low roof towards the front of building.</p> <p>Also circled in the photo is what could be deemed as a large hail impact. These impact marks are sporadic on the roof with the worst being on the west low roof.</p> <p>The impact mark has totally fractured the membrane.</p> <p>There did not seem to be any concentration of moisture north of the adjacent expansion joint towards the opposite end of this photo.</p>

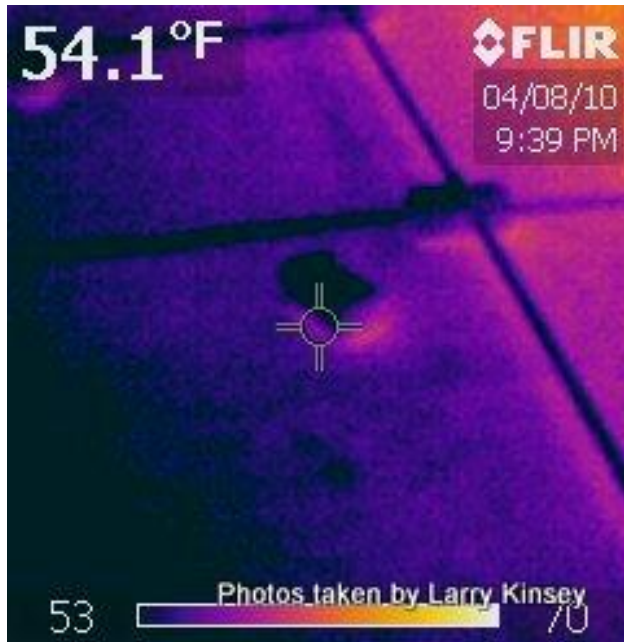
IR Photo # 20	Description east low roof

<p>Photos taken by Larry Kinsey</p>	<p>This IR is looking across the general area noted above.</p>

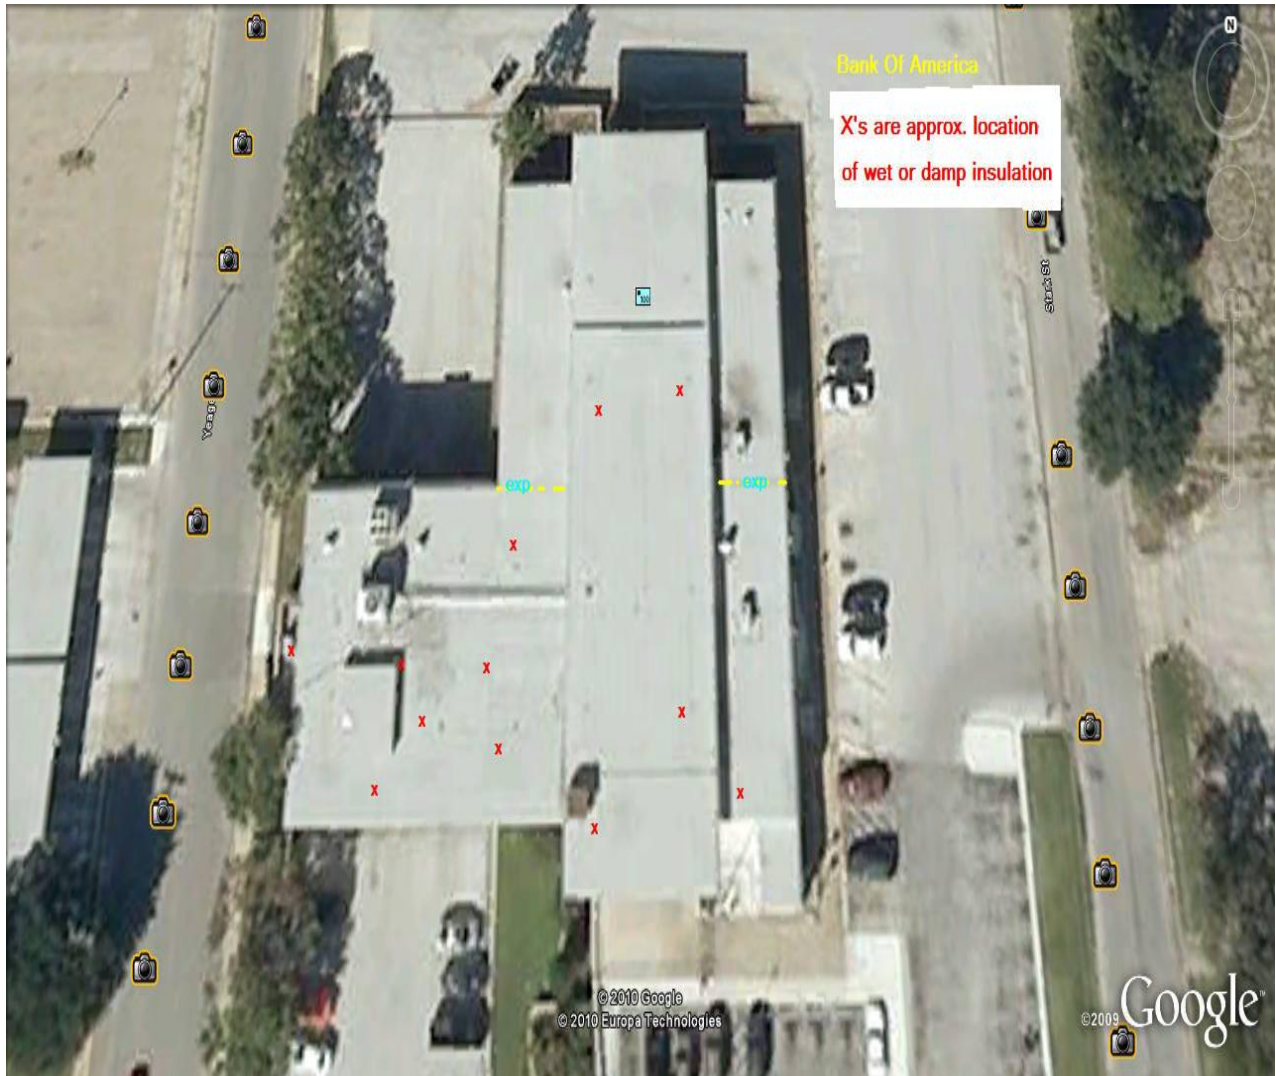
Aerial View Of Roof Marked With X's Indicating Locations Of Wet Insulation
